# COMMERCIAL WINDSTORM MITIGATION INSPECTION REPORT

Bordeaux Village Association No. 1 Inc.

## COMMERCIAL WINDSTORM MITIGATION INSPECTION REPORT (OIR-B1-1802)

Bordeaux Village Association No. 1 Inc.  
2497 Heron Ter (Units C101-106, C203,204)  
Clearwater, FL 33762

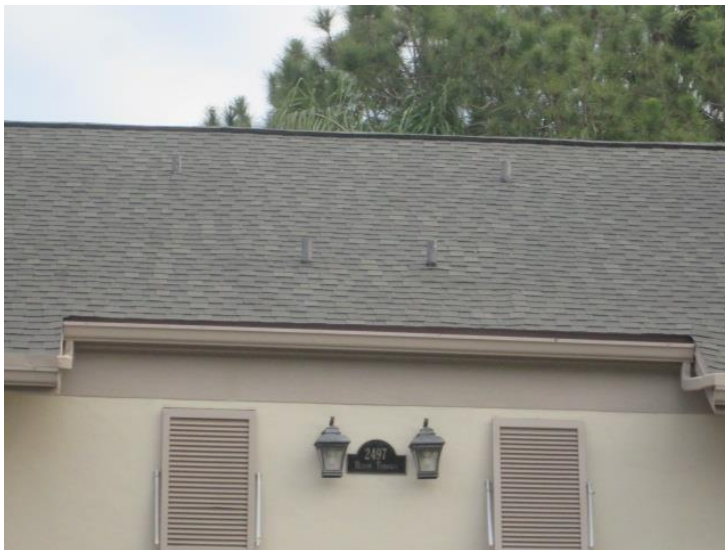
Roof Covering (Section 2)

| <b>2. <u>Roof Covering:</u></b><br>Comments: | <b>FBC Equivalent</b><br>The roof covering was replaced in 2015. The roof permit was confirmed and the permit number is CW15-06972. This roof was verified as meeting the building code requirements outlined on the mitigation affidavit. |

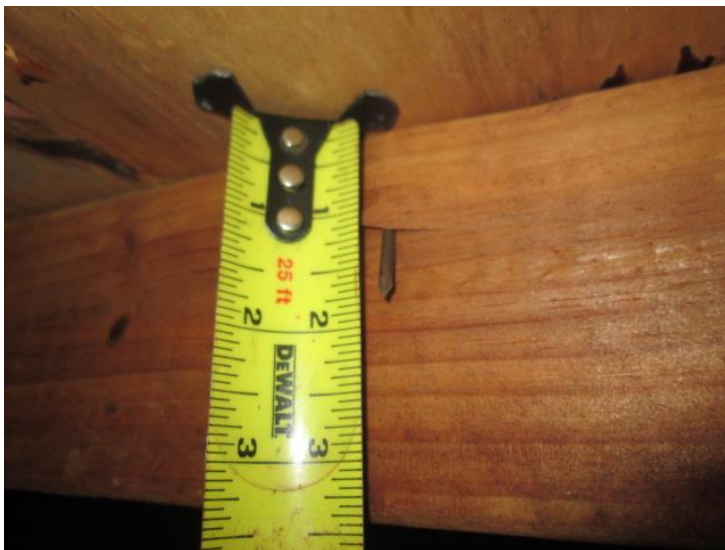
Roof Deck Attachment  
(Section 3)

| <b>3. <u>Roof Deck Attachment:</u></b><br>Comments: | <b>Level C</b><br>Inspection verified 32/16" plywood roof deck attached with 8d nails at a minimum 6" on the edge & 6" in the field. |

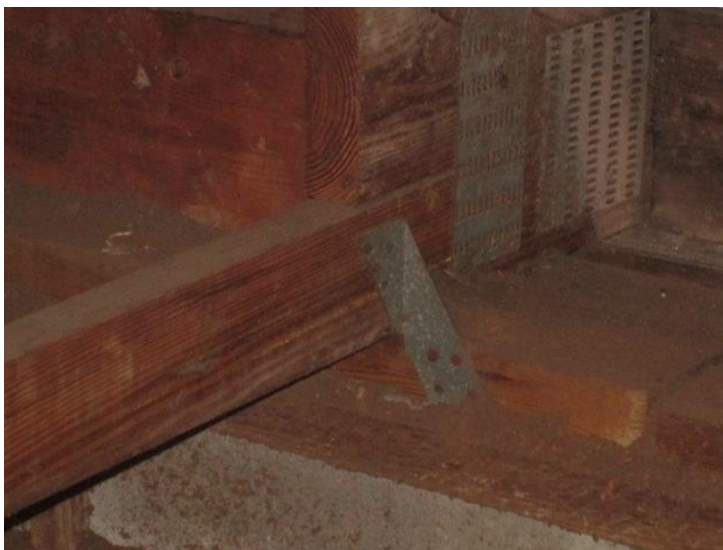
Roof to Wall Attachment  
(Section 4)

| <b>4. <u>Roof to Wall Attachment:</u></b><br>Comments: | <b>Clips</b><br>Inspection verified hurricane clips fastened with a minimum of three nails. |

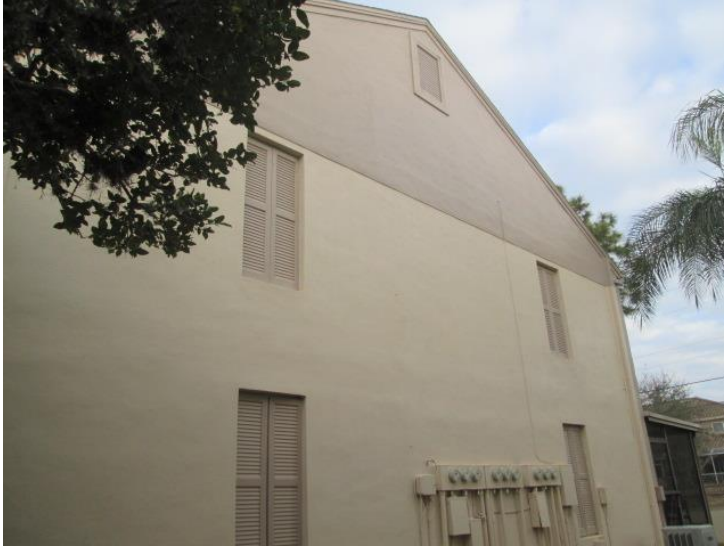
Roof Shape (Section 5)

| <b>5. <u>Roof Geometry:</u></b><br>Comments: | <b>Other Roof</b><br>Inspection verified a gable roof shape. |

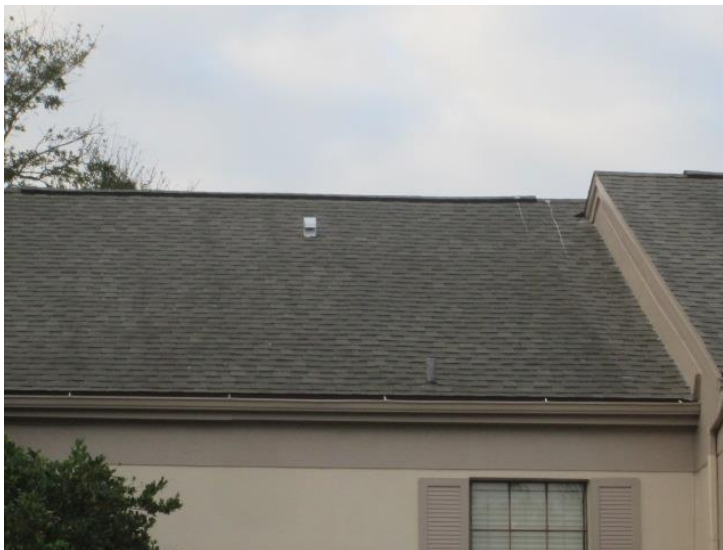
Roof Covering (Section 2)

| <b>2. <u>Roof Covering:</u></b><br>Comments: | <b>FBC Equivalent</b><br>The roof covering was replaced in 2015. The roof permit was confirmed and the permit number is CW15-06974. This roof was verified as meeting the building code requirements outlined on the mitigation affidavit. |

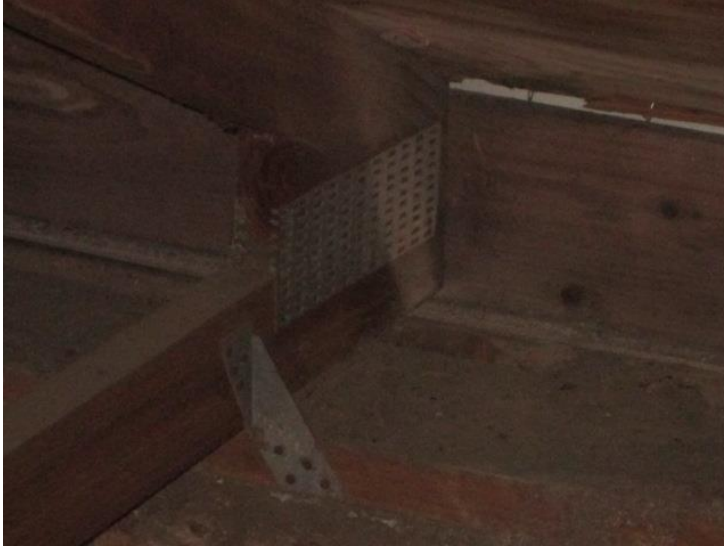
Roof to Wall Attachment  
(Section 4)

| <b>4. <u>Roof to Wall Attachment:</u></b><br>Comments: | <b>Clips</b><br>Inspection verified hurricane clips fastened with a minimum of three nails. |

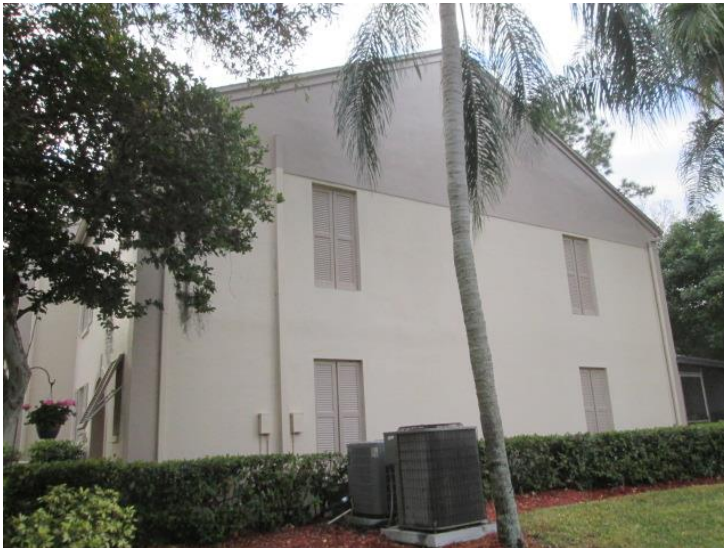
Roof Shape (Section 5)

| <b>5. <u>Roof Geometry:</u></b><br>Comments: | <b>Other Roof</b><br>Inspection verified a gable roof shape. |

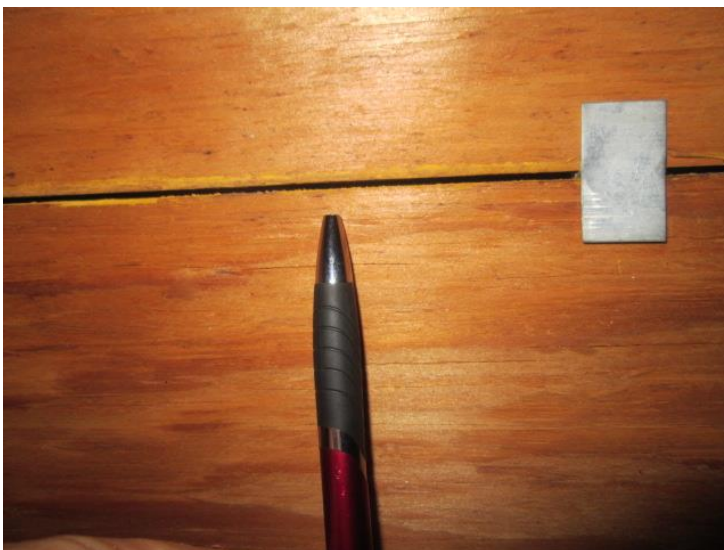
SWR Verified (Section 6)

| <b>6. <u>SWR:</u></b><br>Comments: | <b>Yes</b><br>SWR was verified at time of inspection. The Secondary Water Resistance verified is a self-adhering peel and stick. |
