COMMERCIAL WINDSTORM MITIGATION INSPECTION REPORT

Bordeaux Village Association No. 1 Inc.

COMMERCIAL WINDSTORM MITIGATION INSPECTION REPORT (OIR-B1-1802)

Bordeaux Village Association No. 1 Inc.
2460 Heron Ter (Units E101-04, E201-04)
Clearwater, FL 33762

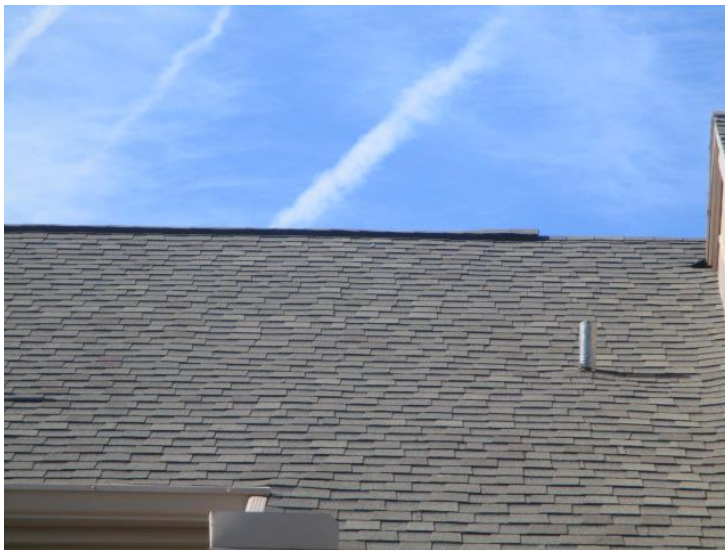
Roof Covering (Section 2)

Comments: | FBC Equivalent
The roof covering was replaced in 2016. The roof permit was confirmed and the permit number is CW16-02080. This roof was verified as meeting the building code requirements outlined on the mitigation affidavit. |

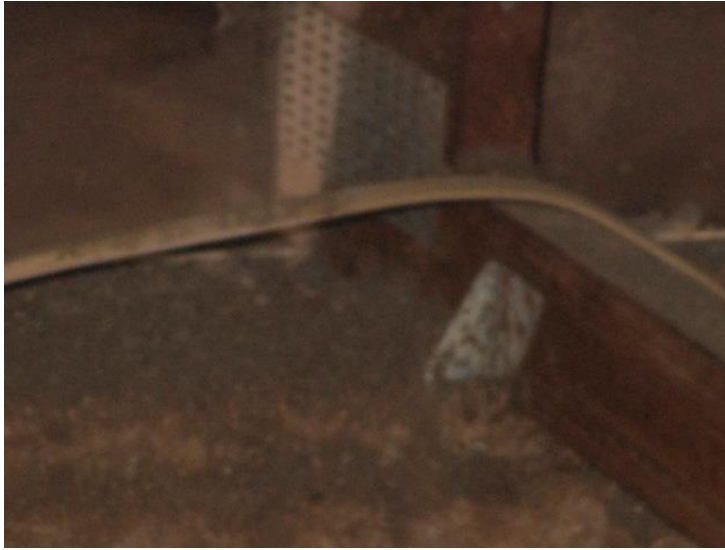
Roof to Wall Attachment
(Section 4)

Comments: | Clips
Inspection verified hurricane clips fastened with a minimum of three nails. |

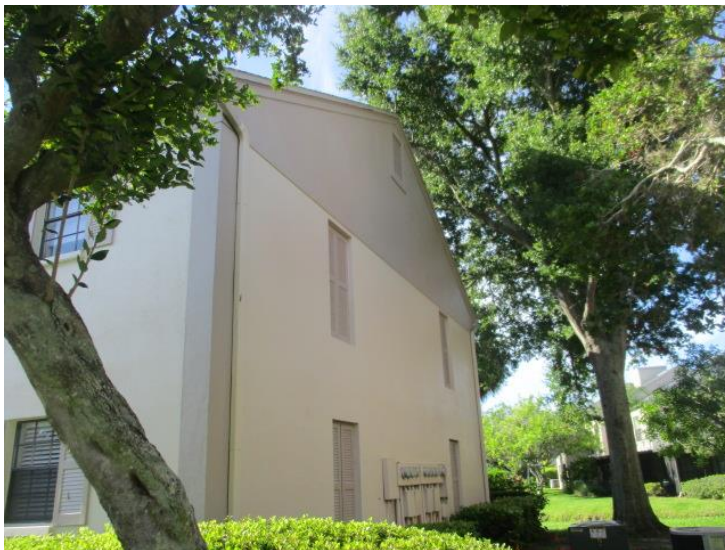
Roof Shape (Section 5)

Comments: | Other Roof
Inspection verified a gable roof shape. |

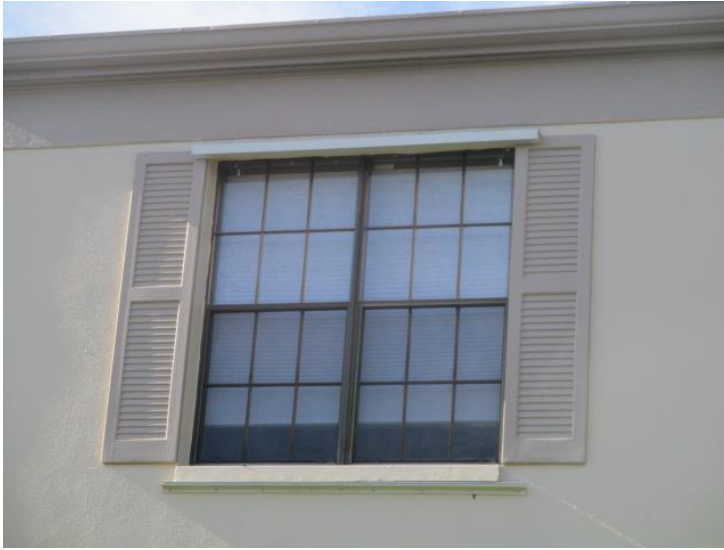
Some Metal Shutter
Opening Protection
(Section 7)

Comments: | None or Some Glazed Openings
Inspection verified some metal or polycarbonate shutter opening protection. Not all glazed openings were protected with impact resistant coverings. |
